Manhole Inspection Summary

Manhole # S25I__061MH

Location Address: **S Carlton st (Southwest Vision) behind 1120** Cross Street: **Hollins ST**

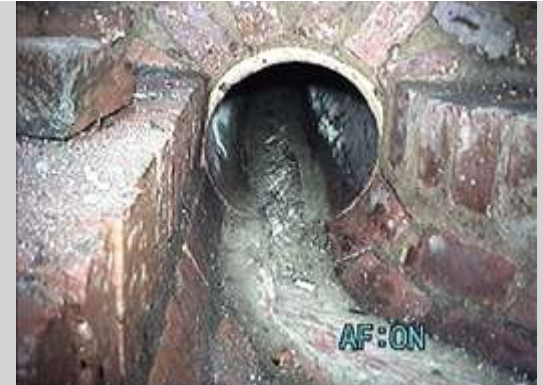
12 O'Clock Outflow

Pipe Height: **8.4** (in.) Rod and Bar (Angled)
Pipe Material: **Clay** ☐ Pipe Lined
Invert Depth: **8.80** (ft.) Flow Characteristics: **Fast**
Deposits: ☒ None ☐ Mud ☐ Sludge ☐ Debris ☐ Grease
Silt Depth: **0** (in.) Deposits Extent:
Infiltration: **None** Pipe Seal Cond: **Sound**

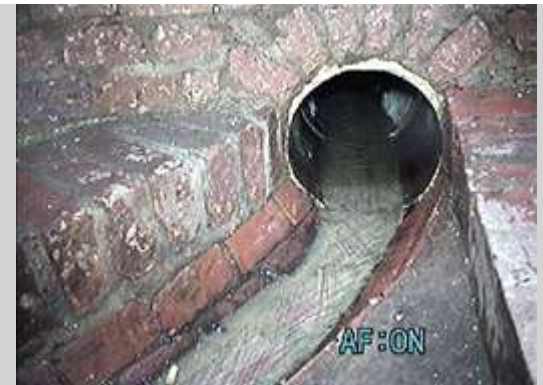
3 O'Clock Inflow

Pipe Height: **8.4** (in.) Rod and Bar (Angled)
Pipe Material: **Clay** ☐ Pipe Lined
Invert Depth: **8.71** (ft.) Flow Characteristics: **Fast**
Deposits: ☒ None ☐ Mud ☐ Sludge ☐ Debris ☐ Grease
Silt Depth: **0** (in.) Deposits Extent:
Infiltration: **None** Pipe Seal Cond: **Sound**

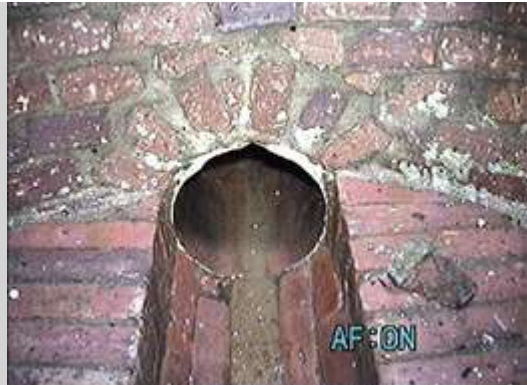
6 O'Clock Inflow

Infiltration: **None** Pipe Seal Cond: **Sound**
